## **Blasting soft, plastic mineral inside a silo at a copper mine**

**Benjamin Cebrian**

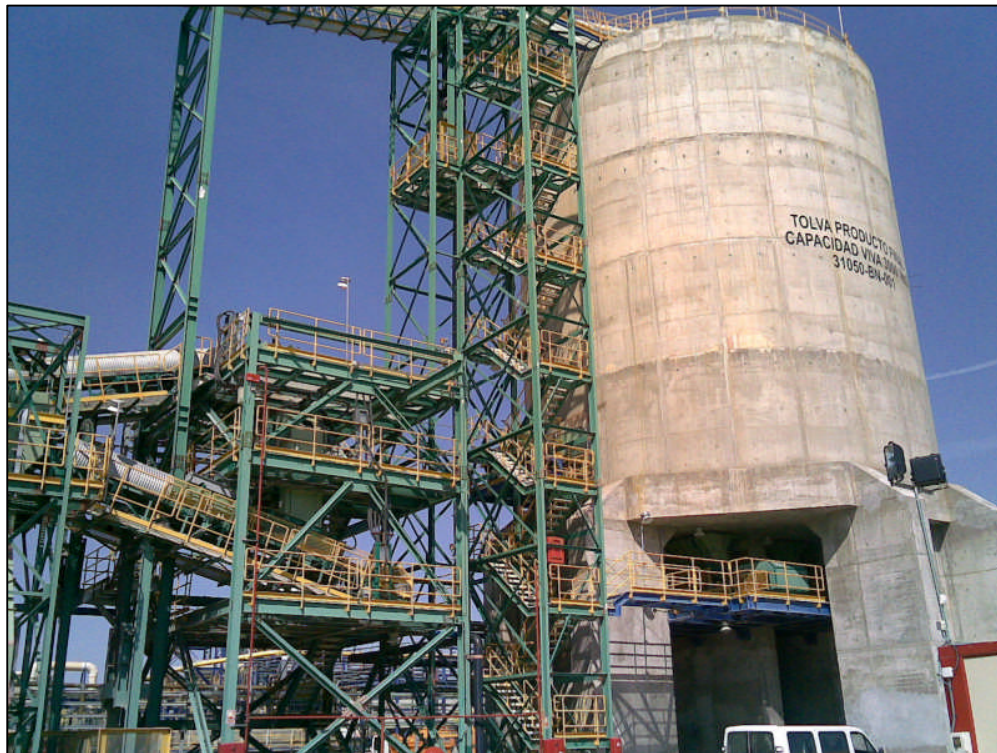
*Figure 1: Fines silo of 3000 tonnes that contained wet, fine gossan ore that hardened due pressure and humidity, preventing flow at the feeders*

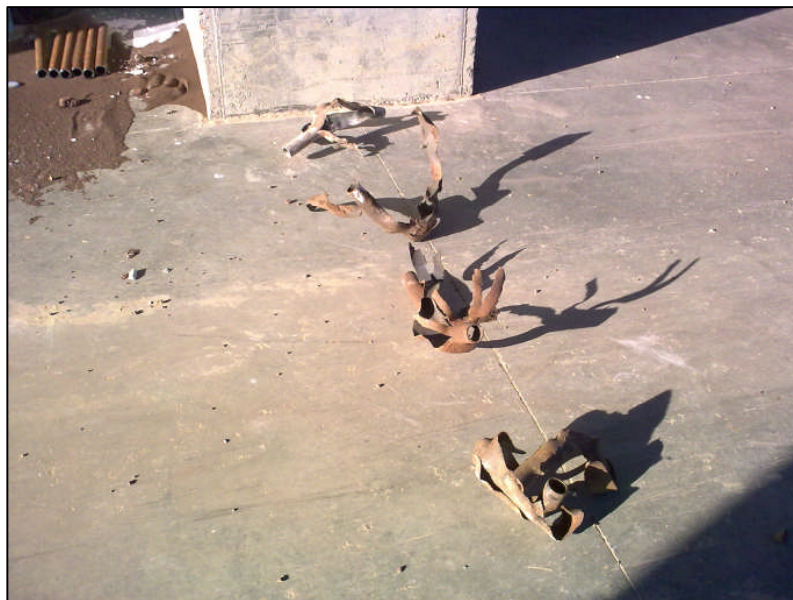
*Figure 2: Some of the metal tubes recovered at the feeders after shooting*

A mix of gypsum and cement was prepared as a fast reaction stemming material that would fill the surroundings of the hole. Although this was useful at some point, the best results were achieved by introducing pyrotechnic cartridges into metal tubes and stemming them with gypsum on both ends.

This latter design proved very useful in confining gasses and raising their pressure before it was released. An increase of charge diameters of around 5 times was detected by the recovery of blasted steel tubes after shooting. This was enough to push and displace gossan around the holes and resulted in the clearing of the 3 feeders.

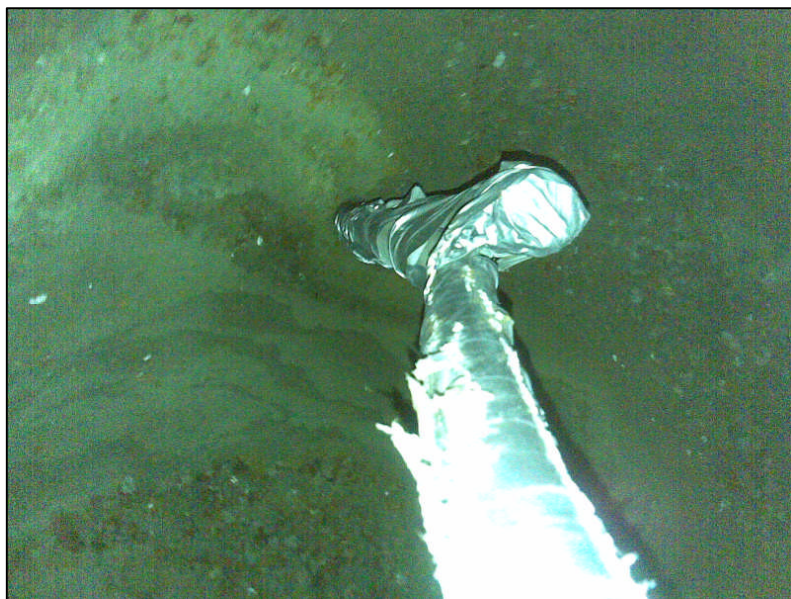
*Figure 3: Once the cavity progressed upwards and into the silo, the only safe way to place the cartridges was attaching them to a long pole and inserting them in holes drilled with long compressed air spears.*

In order to ensure safety, it was not allowed to place by hand at the face of the area to be blasted the cartridges. Instead, charges were placed at the end of poles which helped inserting them to the end of the holes from outside the silo. This was a slow, delicate maneuver, as it was easy to break electric cables and/or have the charge falling outside the hole.

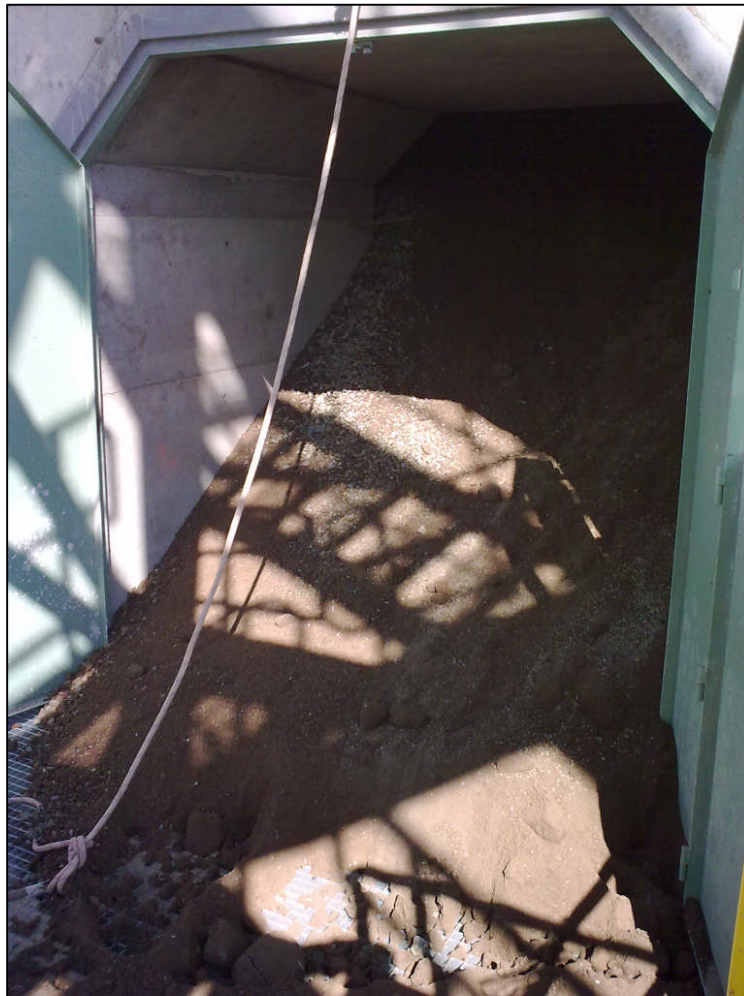
*Figure 4: Minutes after shooting several charges at once at the bottom of the gossan wall, a large amount of ore collapsed into the feeder and overflowing through the side door*

A large number of charges were used simultaneously on the larger face achieved, with the possibility of placing a simple pattern of holes of 2 rows maximum, creating a cutting wedge on the gossan as when chopping down a tree.

Few minutes after firing this larger round of 8 charges, several tonnes of gossan fell on the feeder number 1, filled it and pushed through the door until it was full to the ceiling. Had any worker being there at that time, it would have been under a serious safety situation.

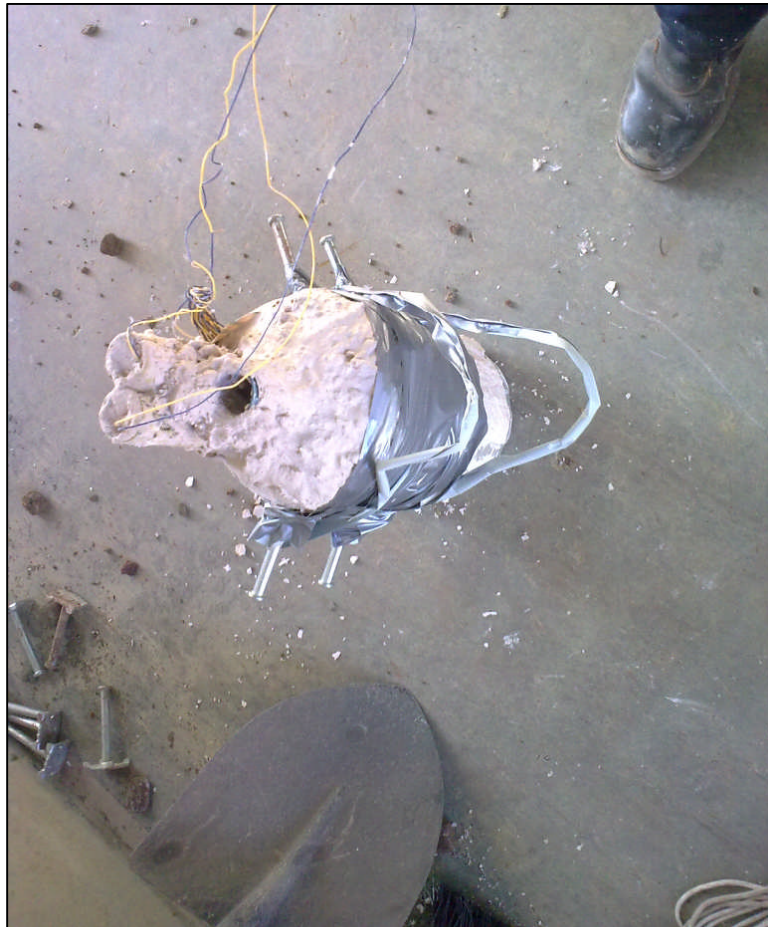
*Figure 5: A self stemmed double charge was created to be placed on top of the ore. This had to have side stabilizers to prevent rollover and ensure downward actuation*

Since there was no way to drill from the roof of the silo, a charge design that would direct the effect of the explosion downwards was created with hand ready items. This charge had to be self stemmed and stable in order to prevent rollover of it. The result of this design was two pyrotechnical charges on steel tubes on the side of a gypsum barrel.

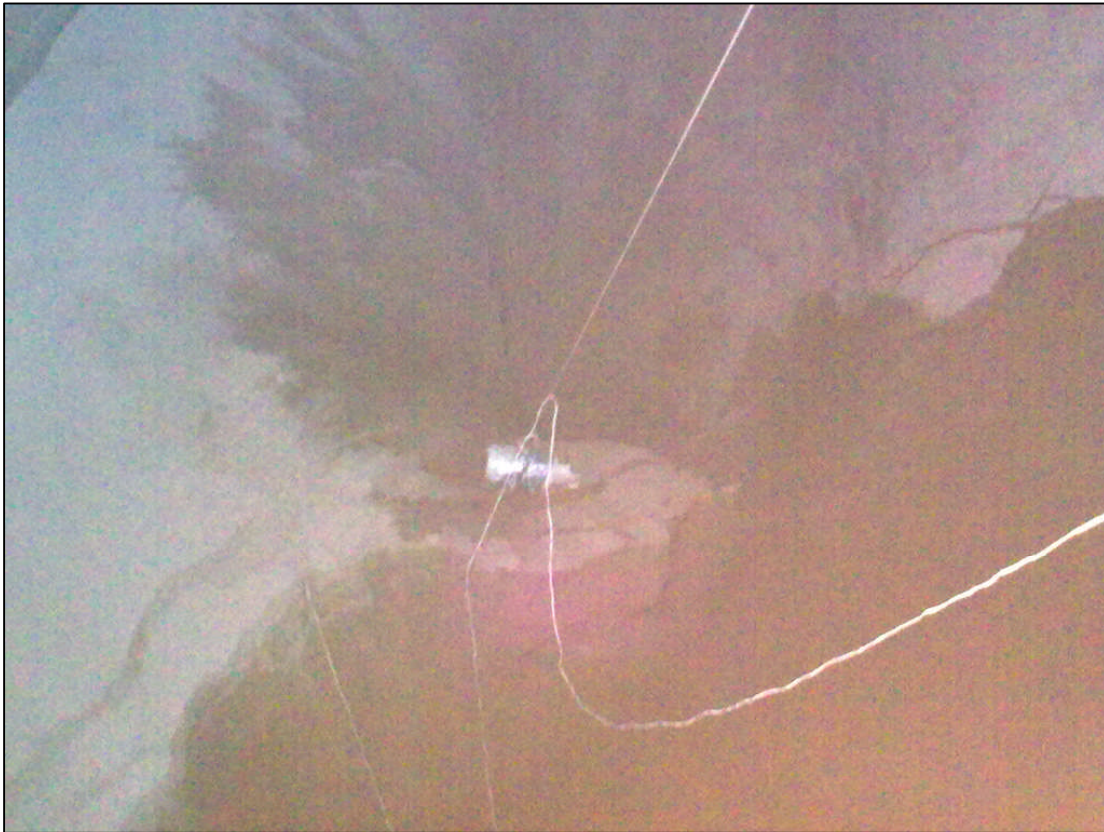
*Figure 6: Placing the double charge on top of the crests created in between feeders. It was lowered with the help of a long rope. It had limited effect, although helped on collapsing part of the crest and, by air blast, shake the surrounding ore.*

An additional and complementary way tested to increase the collapse of material was placing a charge on top of the crests over cones created under the feeders and had reached surface.
